LANDSAT 3 RETURN BEAM VIDICON RESPONSE ARTIFACTS:

**A Report on RBV Photographic Product Characteristics and
Quality Coding System**

EROS Data Center
U.S. Geological Survey
Sioux Falls, South Dakota 57198

August 1981

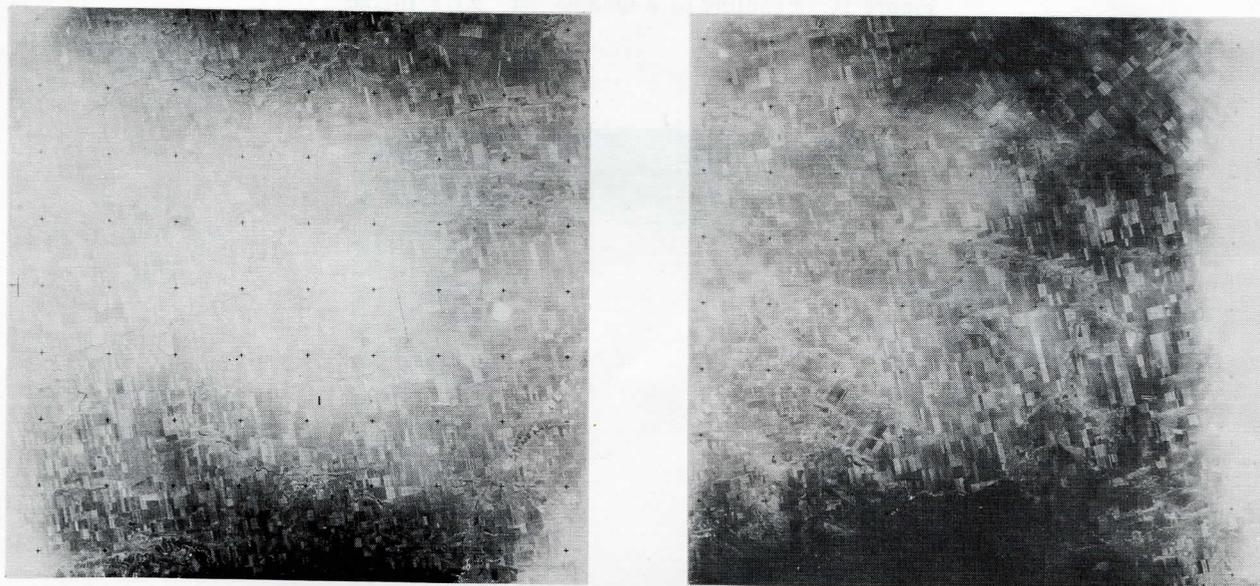
Figure 3. Examples of Shading in Two Adjacent Subscenes

Shading is most obvious when the data acquired lie within a relatively narrow range of gray levels. Differences from camera to camera can be seen in Figure 3 where overall scene density varies considerably between two adjacent subscenes. The left-hand image in Figure 3 also shows how variations in camera response from point to point across the camera faceplate can produce camera-unique shading patterns. Some shading is evident in the right-hand image, as well.

The prelaunch tests were performed in order to collect enough information to minimize these differences during ground processing after launch. Although minimization has been accomplished, it has been impossible to remove these effects totally. The result is a residual, spatially-varying, gray-level-dependent shading in most RBV images. Shading is unique to each subscene, and it affects some images more than others.

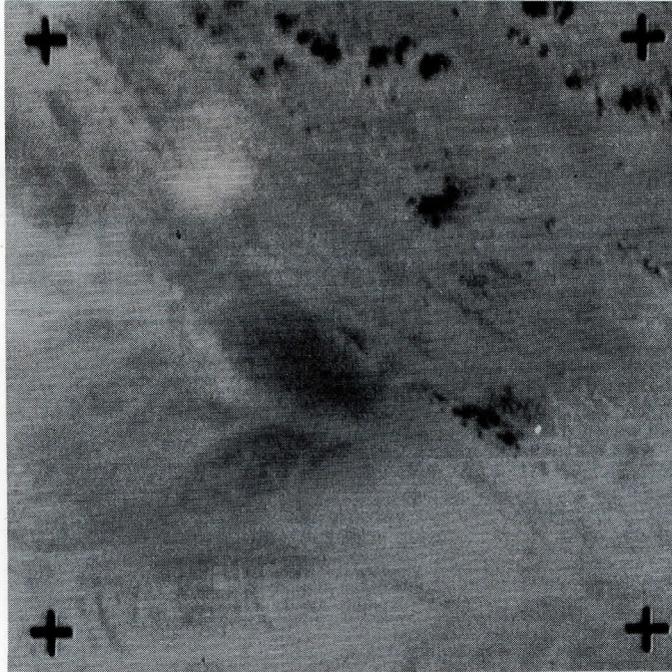
Figure 5. Enlarged Corner Area Illustrating Poor Focus

For some RBV data, it is obvious that the corners of the image are out of focus when compared to the more central parts of the image. This is a vidicon tube characteristic and can be seen in the raw data. While the optics system could be at fault, the cause is much more likely to be thermal perturbations or a phenomenon known as "beam-landing" error. The effect is aggravated by imperfect deshading and the presence of high-frequency noise (causing spatial distortions) when either of these occur. Figure 5 is a good example of a poorly focused corner. Note the blurred reseau mark.

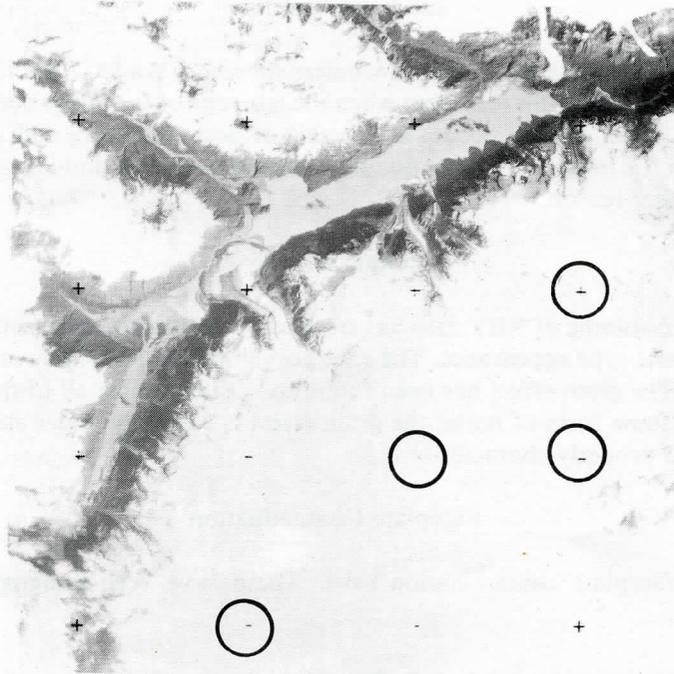
Figure 6. Examples of Incomplete or Missing Reseau Marks

The reseau marks that have been inscribed on the faceplate of each camera can appear to be lost in an image when they occur among data that lie at either radiance extreme. For low-radiance data, the reseau marks merge into the background and are obscured. For high-radiance data, the reseau marks can be washed out or lost due to a vidicon characteristic called "blooming." The latter effect is probably a result of the gain setting on the RBV sensor and cannot be corrected by ground processing. Figure 6 is an enlargement of an image where high-radiance image data have caused reseau marks to be missing.

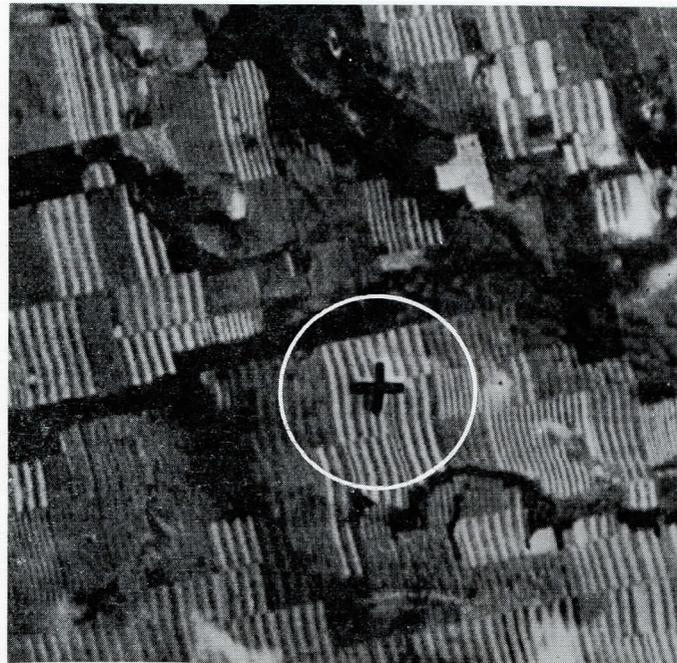
Figure 7. Examples of Data Distortion

Distortion in reseau marks and image data can occur when the raw data contain time-code-induced anomalies. The enlargement in Figure 7 contains some reseau marks that are badly curved, and the image data near them, as well as elsewhere, are similarly distorted. Minor data losses in the time-code signal are thought to cause this horizontal shifting of data. Although this effect is not restricted to any area in an image, it is usually most pronounced in the corners of the image.

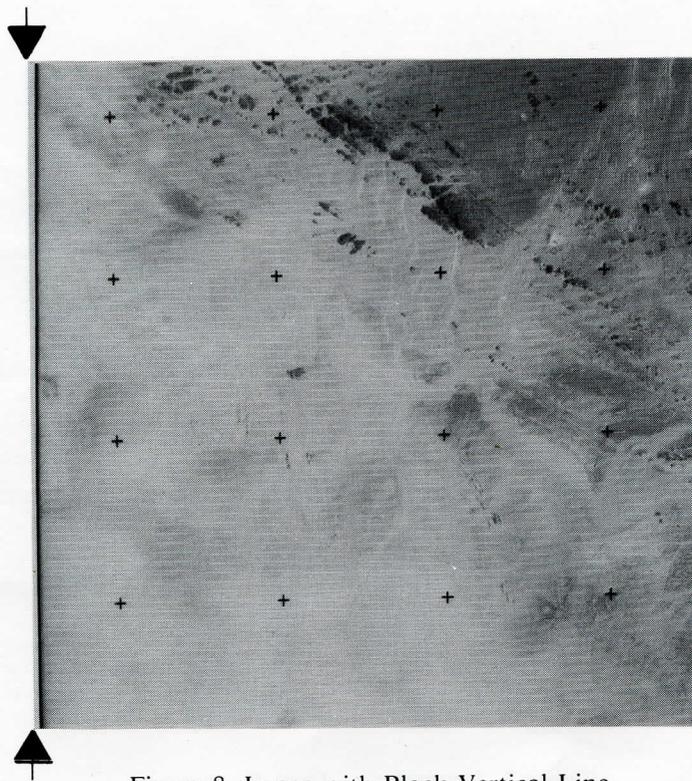
Figure 8. Image with Black Vertical Line

Image data acquired by camera no. 2 (which acquires subscenes B and D) contain a thin black line along the left vertical edge of the image. This is evident when the left edge of the image contains high-radiance data. Figure 8 is one example. This artifact occurs as a result of both hardware and software problems in the ground processing system. Its impact on image quality is strictly cosmetic, and it is shown here more for completeness than for any other reason.

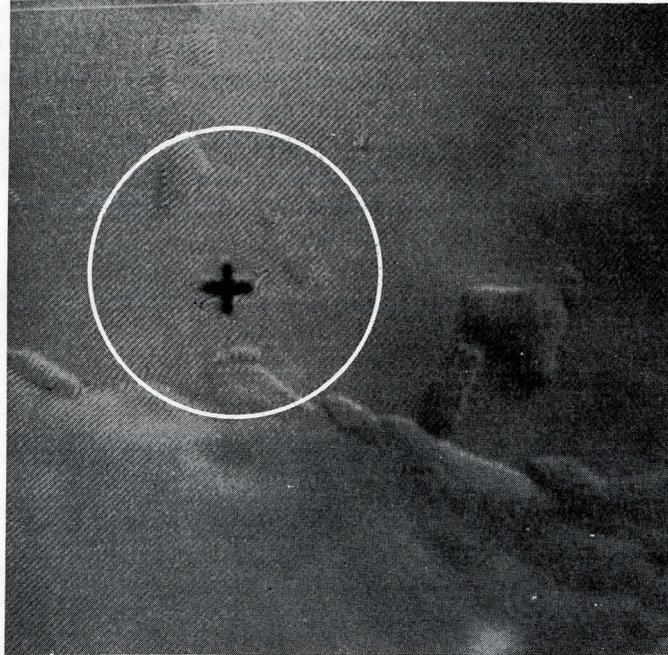
Figure 9. Example of Graining

Production of a large volume of RBV data has resulted in the identification of specific images that contain a "graining" or a fabric-type appearance. The enlargement in Figure 9 shows an example of bad graining in the upper left corner. The grain effect has been found to exist in almost all of the data processed to date. Probably attributable to some form of noise, the grain effect is currently under analysis at GSFC where attempts are being made to properly characterize it.

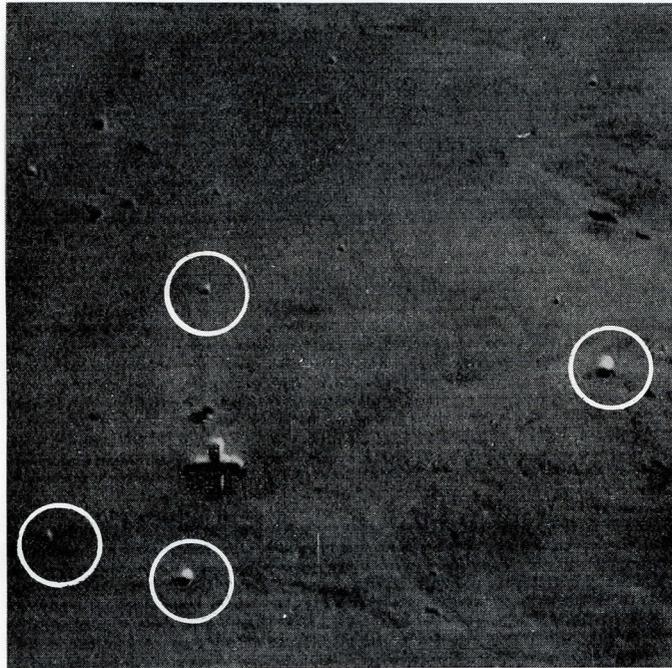
Figure 11. Examples of Tears

The second type of faceplate contamination cannot be seen clearly unless the proper combination of sun angle and scene radiance exists. When these conditions exist, one can detect bright white pinhole-size spots that are each accompanied by a black "shadow" of unknown origin. These are termed tears. The enlargement in Figure 11 has examples of tears; at this scale the tear shadows actually seem to be the dominant feature. Tears can be attributed to two causes. In some cases, they are a manifestation of minor flaws in the photoconductive layer of the vidicon. In other cases they represent localized areas of condensate on the camera faceplate. They always occur in the same place, and their detection is dependent upon the gray level of the image data written over them. They appear to be permanent.

Both types of faceplate contamination, hot spots and tears, are uncorrectable by ground processing.

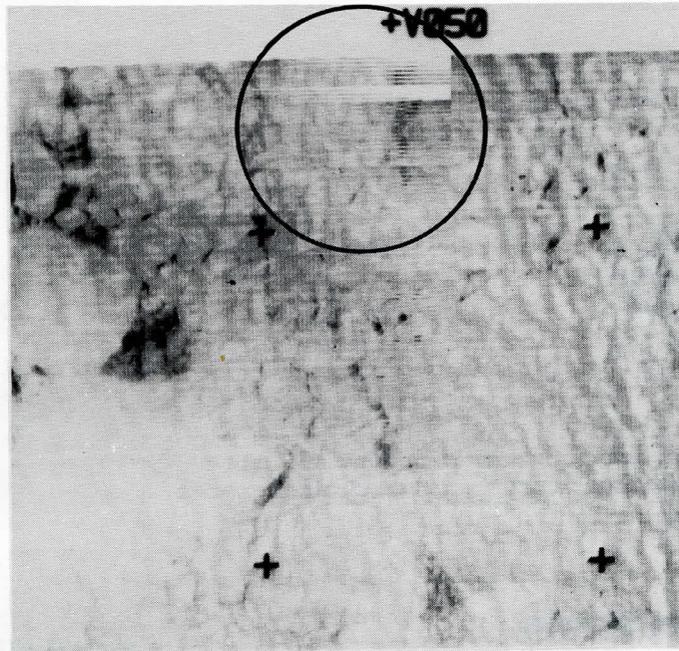
Figure 12. Example of RBV Geometric Anomaly

A small fraction of RBV data has been found to contain a local geometric distortion. Image data in this category can be recognized by the presence of parallel lines restricted to the left one-third of the image. Such an area is highlighted in Figure 12. These lines always occur near the top and on the left-hand side of the subscene. They do not extend into any other one-third segment of the image data, and they are abruptly terminated at the boundary between the left one-third of the data and the center one-third.

This artifact is introduced by ground processing and should be capable of being removed by the same means. A study is under way at GSFC to determine how this might best be done.
