Pictures confirm R

Satellite photos
published
for first time

Red reactor cooling

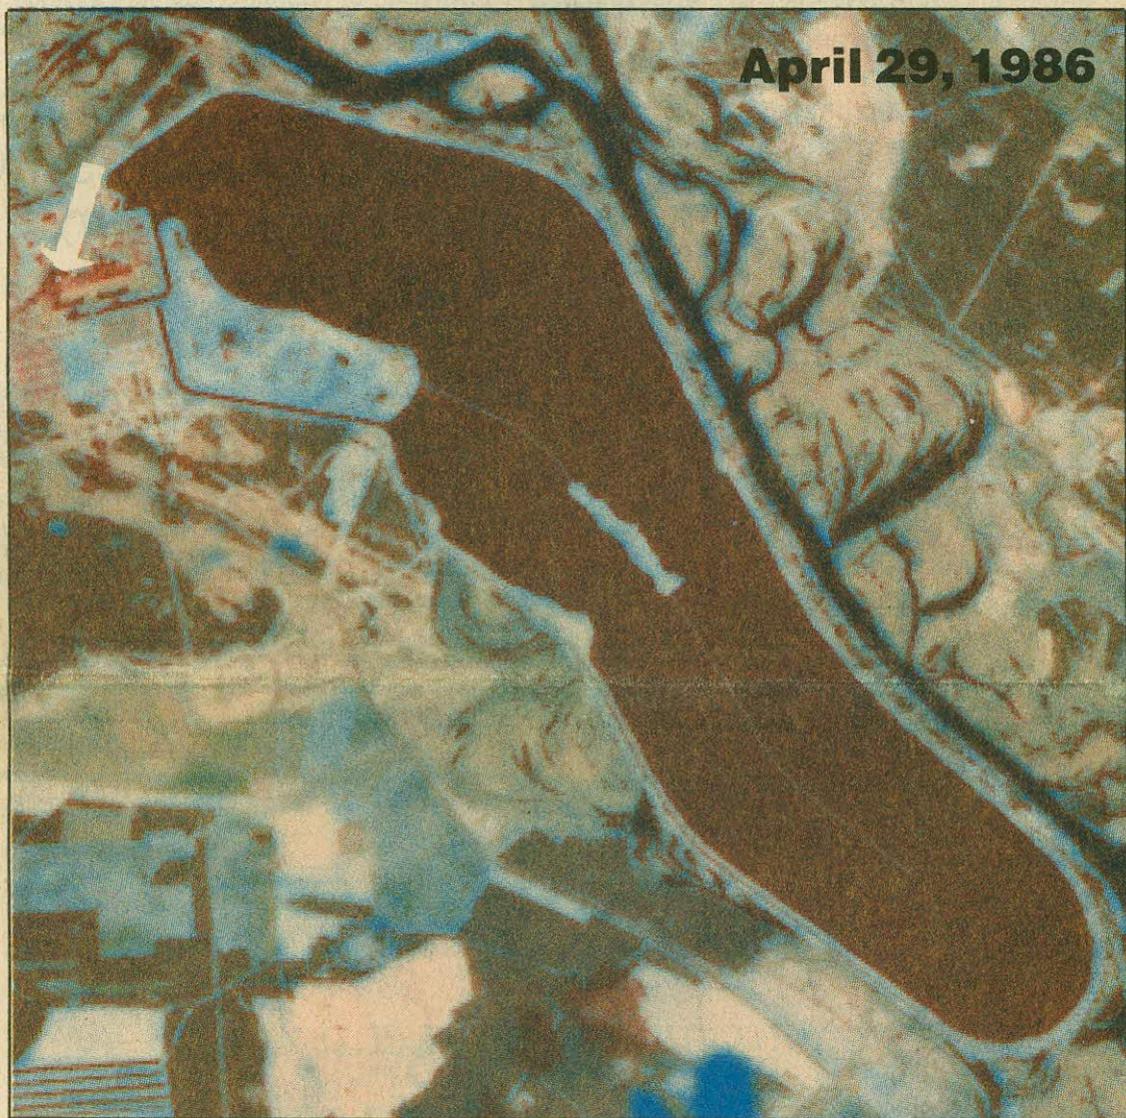
Photo shows holding lake a brownish color, indicating heat from reactor.

The latest photo of the site, taken May 8, shows a "hot spot" at reactor No. 4 is no longer visible, as it was in a photo taken April 29 (arrow), three days after the worst

In addition to the disappearance of the hot spot, water intake channels — the dark "T-shaped" features adjacent to the reactor — appear to be cut off and dry on the May 8 photo, in contrast to April 29.

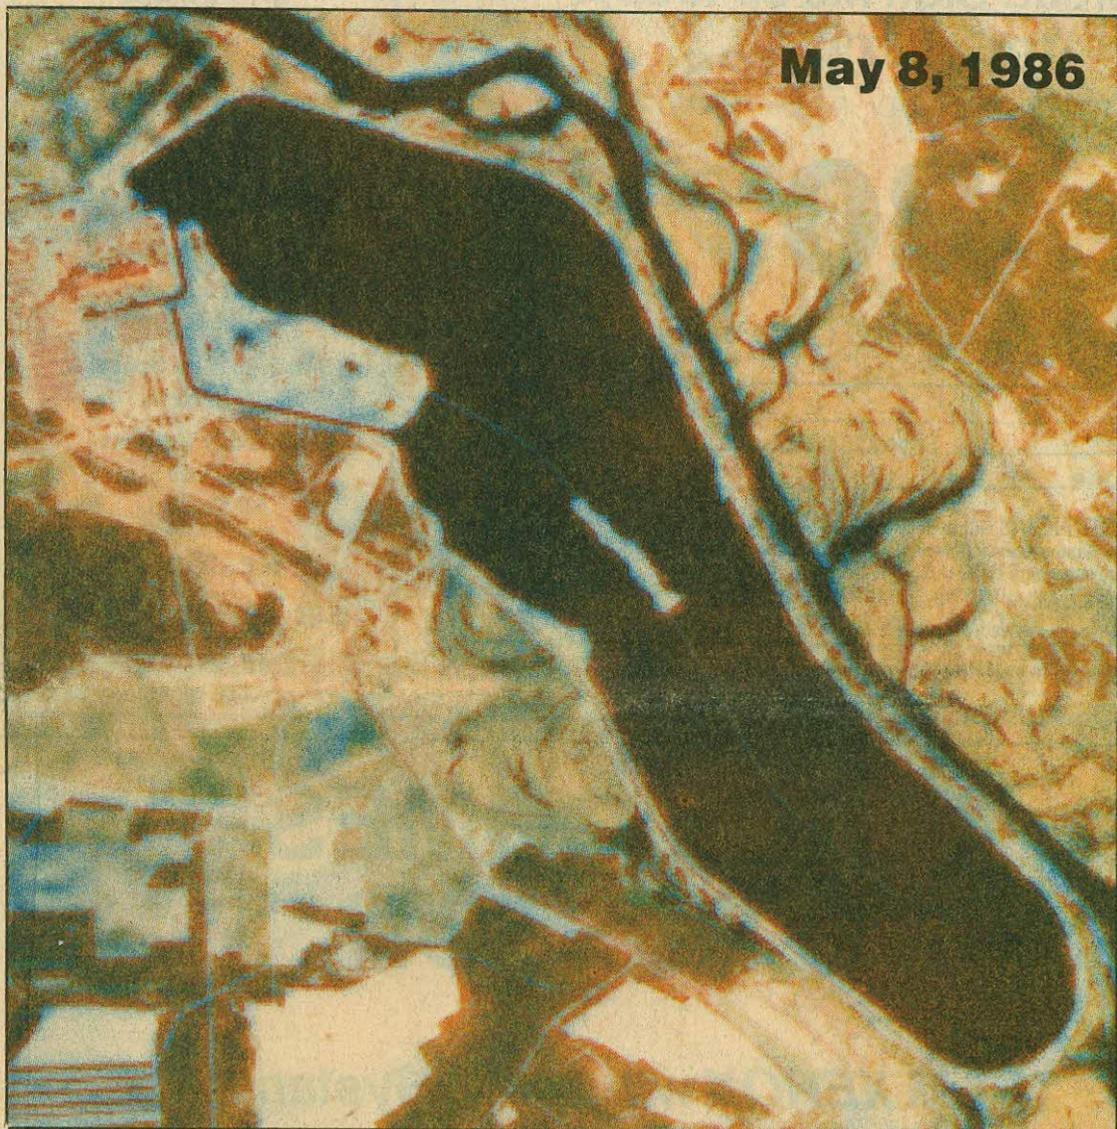
May 8, 1986

Later photo shows lake as black, indicating water has cooled.

U.S.G.S. officials said the May 8 photo shows that Soviet efforts to contain releases of radioactive materials to the air apparently have been successful.
