Before and After Landsat Satellite Imagery of the Northwest Sumatra Coast

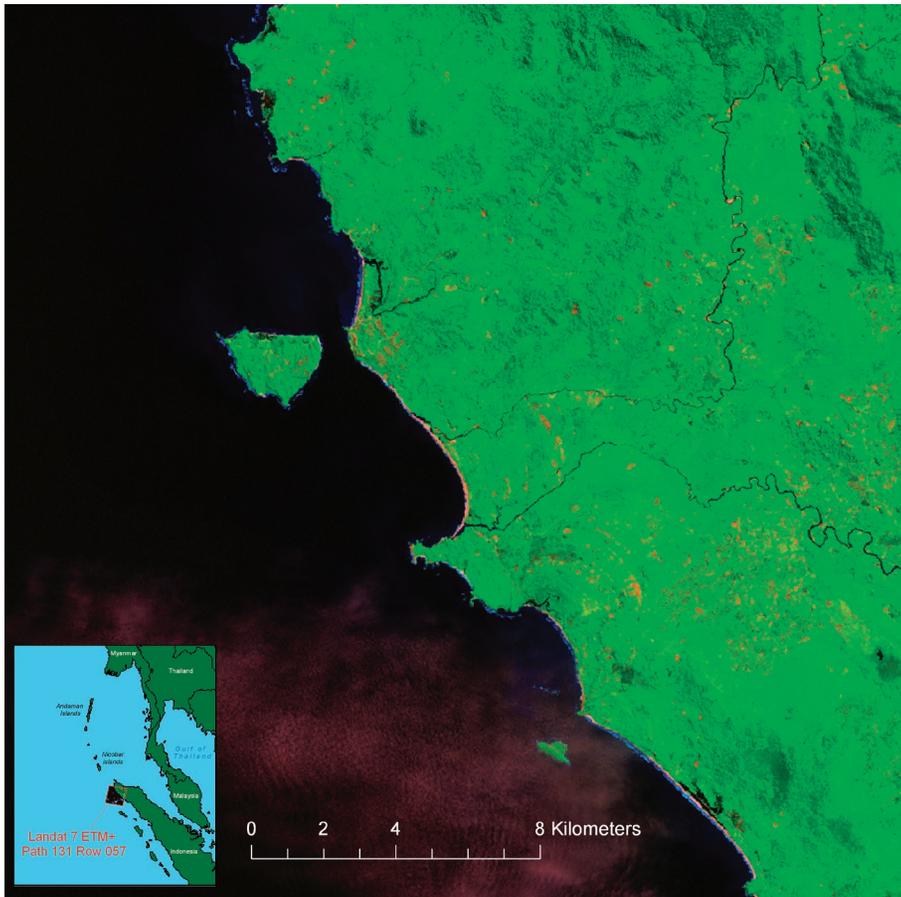
June 12, 2001

The Landsat 7 image on the left from June 12, 2001, shows the northwestern coastline of Sumatra prior to the disaster. The Landsat 7 image on the right from December 29, 2004, shows the same area shortly after the tsunami struck. The tsunami-impacted zone is approximately 30 kilometers (18 miles) long and extends inland nearly 2 kilometers (1.3 miles). Land areas less than 15 meters (50 feet) above sea level were most severely affected.
