# Earthshots

## Isahaya Bay, Japan 1993-2010

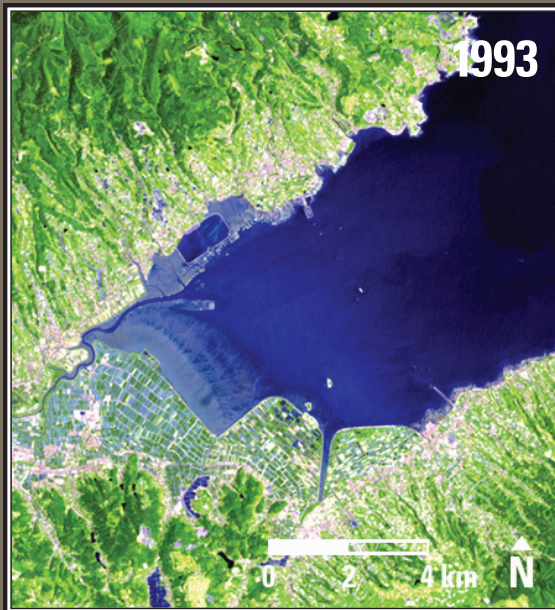
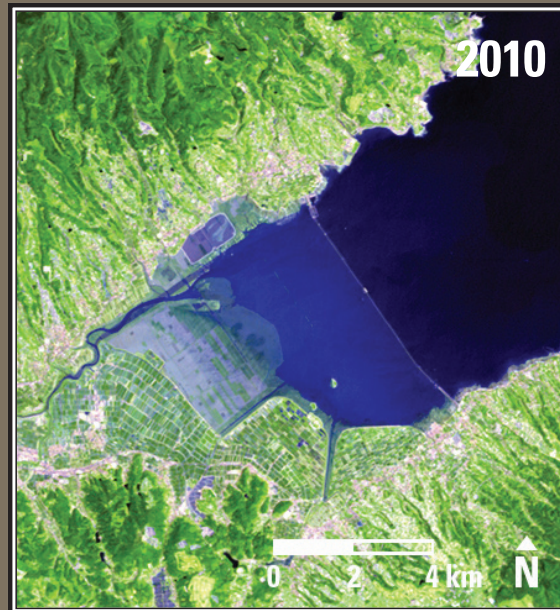
The controversial Isahaya Bay Reclamation Project has been blamed for recent reduced harvests of fish and seaweed (nori). The 1993 image shows the bay before a sea wall was built. In the 2010 image, reclaimed land extends into the area lying behind the 7-km (4-mile) wall.

Date	Satellite	Bands	Res	Path	Row
May 15, 1993	Landsat 5 TM	7,5,3	30 m	113	37
Sept. 3, 2010	Landsat 5 TM	7,5,3	30 m	113	37
